# BOROUGH OF WOODCLIFF LAKE

**AREA IN NEED OF REDEVELOPMENT  
WITHOUT CONDEMNATION**

APRIL 22<sup>ND</sup>, 2025

BLOCK 601 LOT 1  
300 CHESTNUT RIDGE ROAD

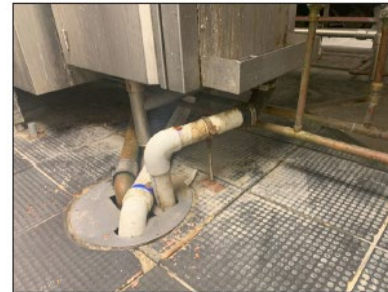
Figure 45: Kitchen washing area with replaced pipes do to failure

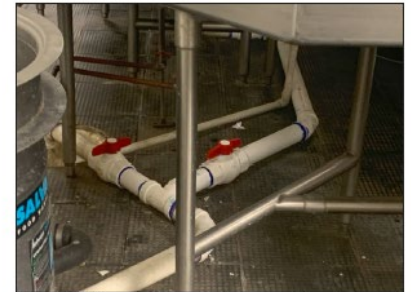
Figure 46: Kitchen washing area with replaced pipes do to failure

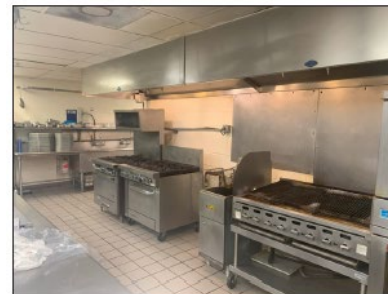
Figure 47: Existing kitchen with original equipment in need of replacement.

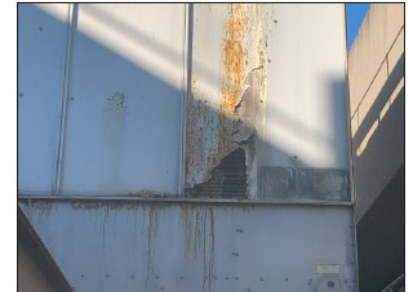
Figure 26: Exterior water tower with signs of degradation

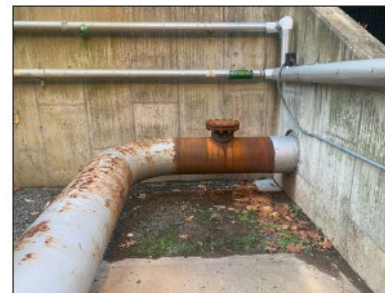
Figure 27: Exterior water tower with signs of degradation including a replacement of a section of the pipe due to failure

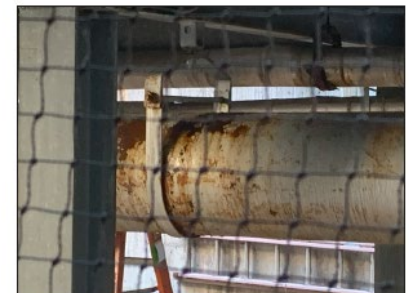
Figure 28: Exterior water tower with signs of degradation including a replacement of a section of the pipe due to failure

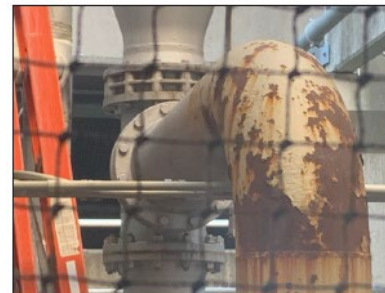
Figure 29: Exterior water tower with signs of degradation including a replacement of a section of the pipe due to failure

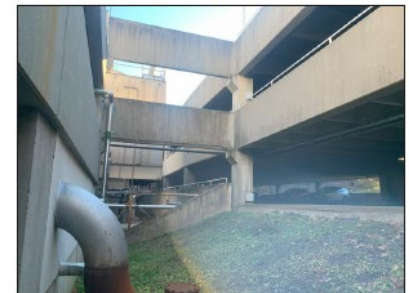
Figure 30: Exterior water tower with signs of degradation including a replacement of a section of the pipe due to failure

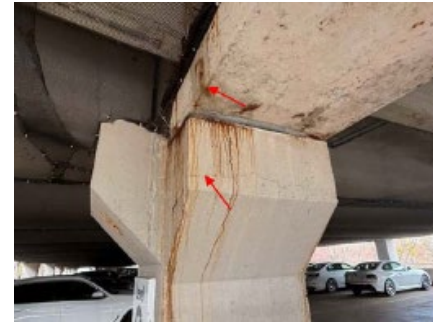
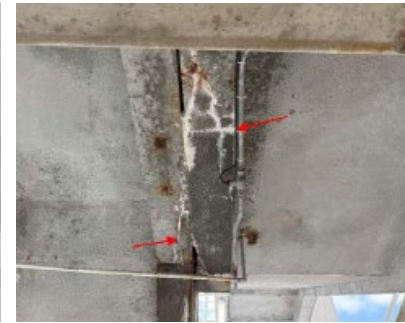
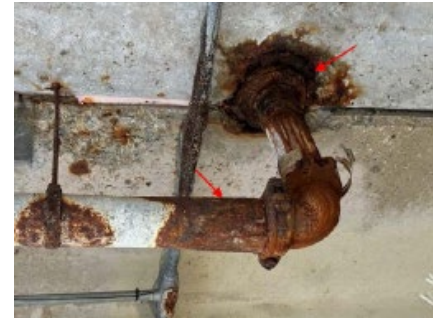
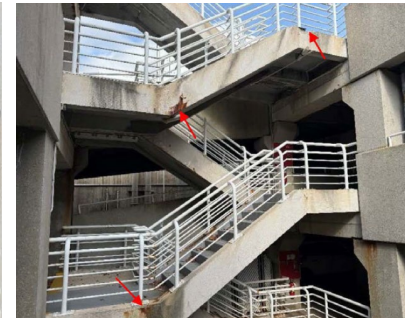
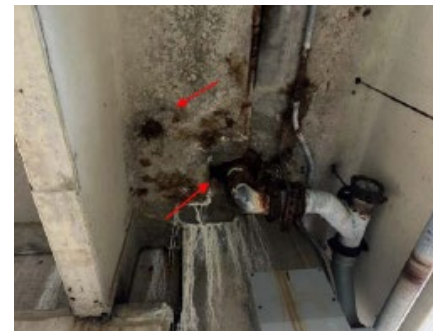
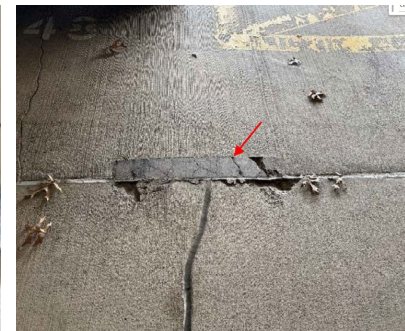
7. Skylights to be repaired or completely replaced
  8. Column concrete cracks and spalls in select areas
  9. Stair tower displays several types of corrosion such as precast concrete beams and underside of stairs

10. 35-y/o parking structure under-maintained, damaged from freeze-thaw cycles
